**Flood Control Project Maintenance  
Levee Inspections**  
**LMA District Cover Sheet**  
**Spring 2009 Levee Inspection Results**

**Reclamation District No. 0787**

Waterway		Bank	Unit Miles
Unit No. 01 Colusa Basin Drain		Left	4.40

**Levee Inspection Report By Mile - Spring 2009**

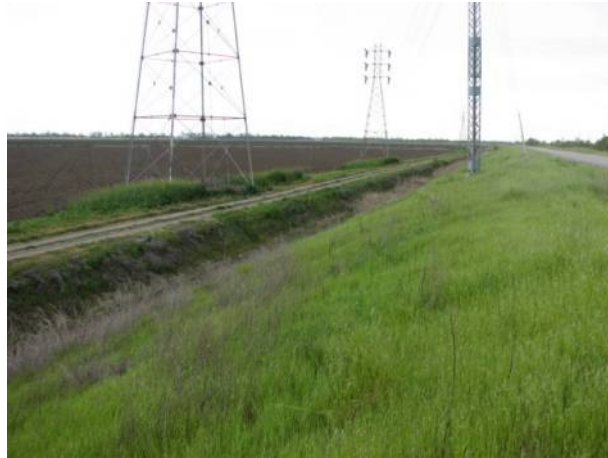
Levee Mile Report Line	4
Start Levee Mile	1.57
End Levee Mile	2.71
Location	Land Side
Category	Earthen Levee
Item	Encroachments
ag. ditch runs along land side the distance of the district
